Innovative Geotextiles for Reinforcement of Roadside Ditch

Original Scientific Article

Geotextiles consisting of meandrically arranged coarse ropes were produced. For the production of the ropes Kemafil technology was applied and the wastes of various nonwovens were used. The geotextiles were used for the protection of the roadside ditch in a clay ground. After installation of the geotextiles ensured immediate and effective protection of the ditch. During heavy rains the meandrically arranged geotextiles formed a system of cascades which slowed down the stream of water flowing in the ditch. Additionally, the retention of water between the meanders of geotextiles and water absorption inside the ropes was observed. The materials used for the production of geotextiles had sufficient resistance to biodegradation and ensured the protection of the ditch at least for one growing season.

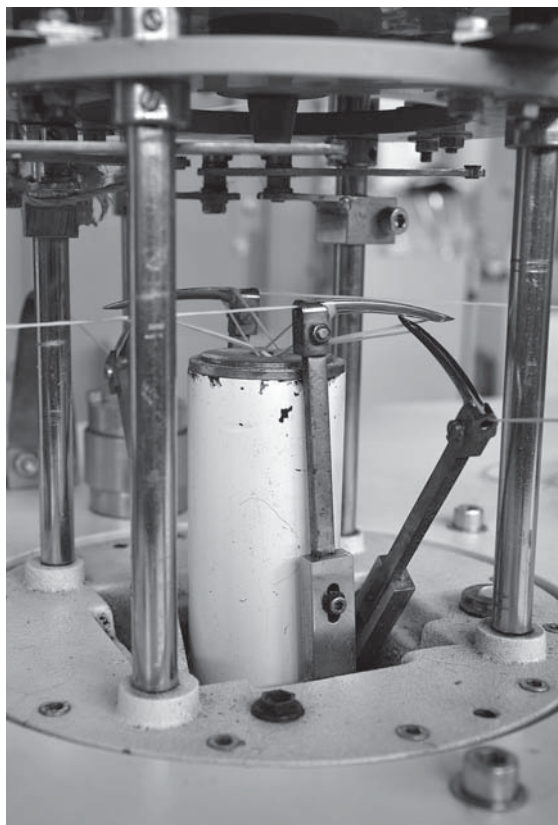
Figure 1: The guide tube with loopers in the Kemafil machine

Some years ago innovative geotextiles created from meandrically arranged coarse ropes, produced by Kemafil technology, were invented [2]. The technology involves the use of a small circular knitting machine which is equipped with four hooked loopers arranged around a guide tube (Figure 1). The threads guided by the loopers form a tubular knitted sheath around the core. The sheath consists of four stitch courses running parallel to the longitudinal axis of the ropes and the stitch wales running spirally around the rope [3].

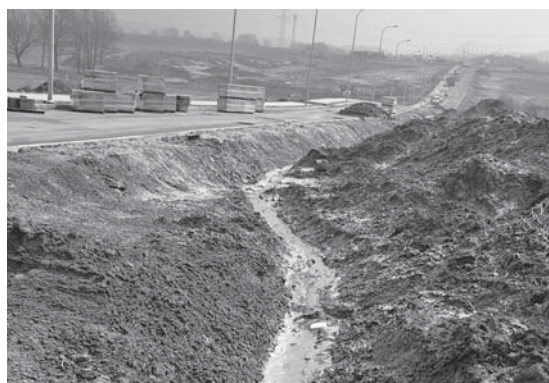
Figure 2: The roadside ditch: (a) during the construction of the road; (b) the ditch lined with concrete panels filled with rainwater

The geotextiles were installed in a trapezoidal roadside ditch, which was built along the new road in the hilly terrain near Bielsko-Biala (Silesia, Poland) (Figure 2a). The ditch was built in the clay soil with

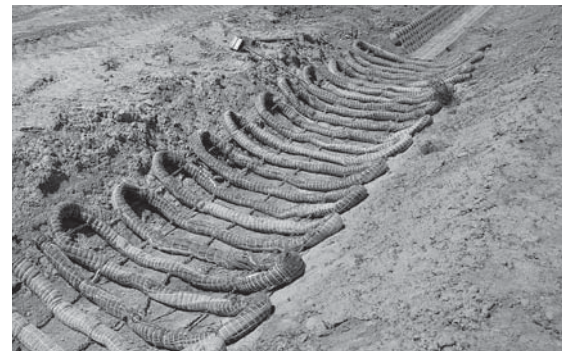
a

Figure 3: Installation of the geotextiles in the roadside ditch: (a) the overall view of the ditch; (b) connection of concrete panels reinforcement with the geotextiles

The meandrically arranged geotextiles were installed as the lining of the part of the ditch between the sections lined with the concrete panels (Figure 3a). For the installation of geotextiles the site with the highest road inclination was chosen. The segments of geotextiles were arranged in the ditch with turns perpendicular to the ditch axis. The middle zone of the segments was laid in the bed of the ditch, while its both lateral zones were bent on the ditch banks. The ropes were anchored to the soil with steel “U-shaped” pins, both to the bottom and the banks of the ditch (Figure 3b).

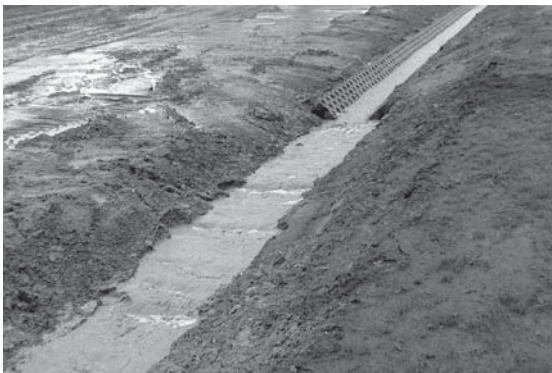
Figure 4: The roadside ditch during exploitation: (a) cascades formed in the flowing stream; (b) retention of water in the ditch

During heavy rains a system of transversal micro-dams was observed on the neighbouring turns of ropes installed in the ditch (Figure 4a). On each rope a small cascade was formed, and thanks to that the stream of water successively slowed down and its erosive action was significantly reduced. During light rains retention of water flowing along the ditch was observed. The water stopped in the space between the neighbouring turns of meanders and was absorbed inside the ropes. Later, during dry days, water absorbed by the ropes was slowly released (Figure 4b).

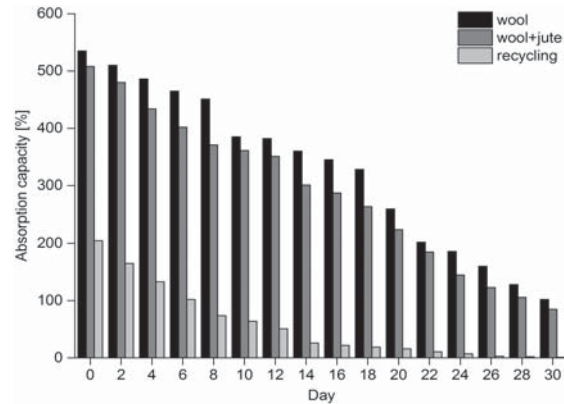
Figure 5: Water absorption capacity of the Kemafil ropes produced from different materials

The water absorption capacity of the ropes depends on the materials used for their production. The absorption capacity of the ropes produced from woolen nonwoven and wool/jute composite is high and equals 535% and 510%, respectively (Figure 5).

During drying in the free state the water absorbed in the ropes is slowly released and the water content is systematically decreased to approximately 100% after one month of drying. The absorption capacity of the ropes made from recycled fibres is much lower and amounts to 205%. During drying the ropes return to the weight of a dry product in one month.

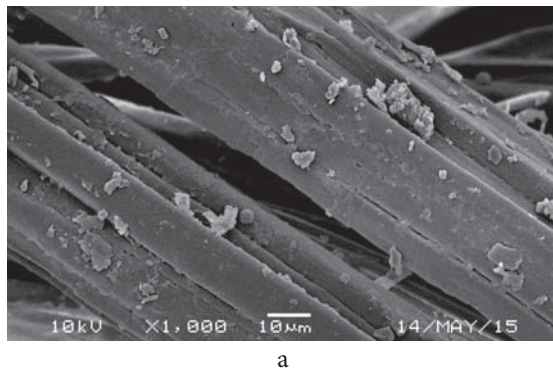
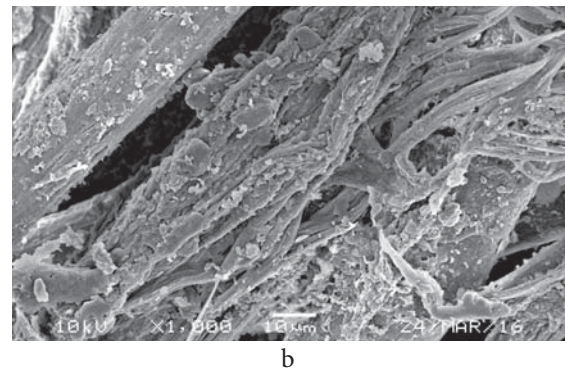
Figure 6: The morphology of jute fibres used for the production of the ropes: (a) before and (b) after six months of the exploitation in the ditch

as a nutrient source. Microorganisms, bacteria and fungi secrete enzymes which systematically degrade the fibres structure. In the case of jute biodegradation leading to fibres fibrillization and complete disintegration occurs very quickly (Figure 6). After six months biodegradation is far advanced and as a result a drastic reduction of mechanical strength of the jute-wool composite is observed.

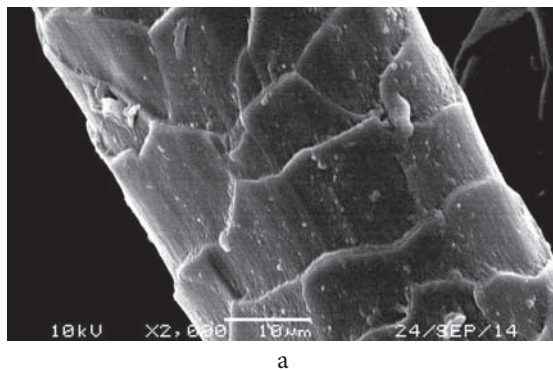
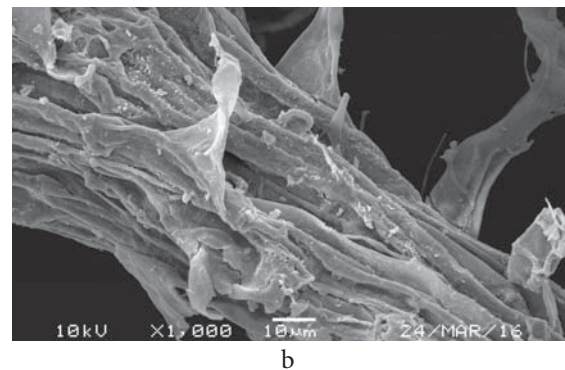
Figure 7: The morphology of wool fibres used for the production of the ropes: (a) before and (b) after six months of the exploitation in the ditch

In the case of wool biodegradation occurs much slower [5]. After six months the characteristic scales observed on fibres surface are practically completely removed and biodegradation causes partial disintegration of the inner parts of the fibres (Figure 7). As a result, a significant reduction of the mechanical parameters measured for the nonwoven produced from wool fibres is observed.

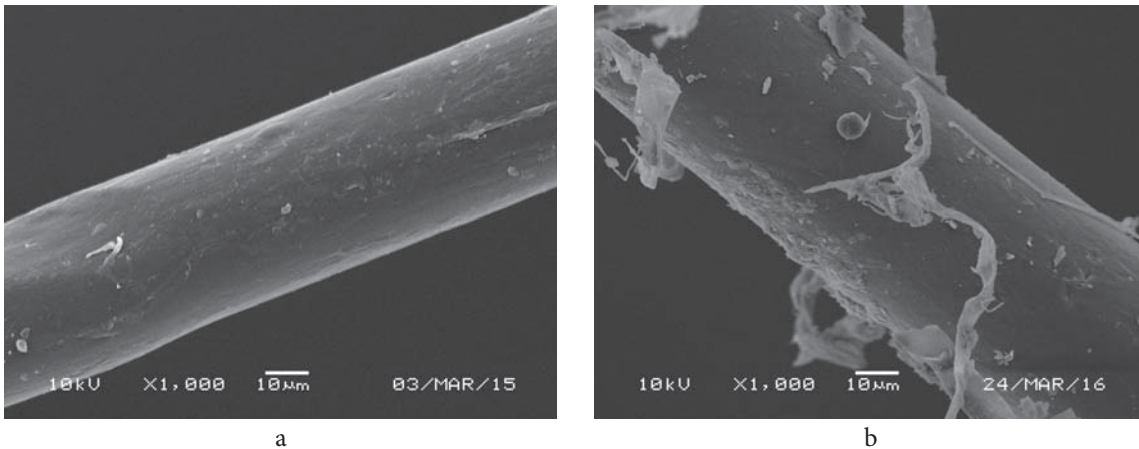
Figure 8: The morphology of synthetic fibres used for the production of the ropes: (a) before and (b) after six months of the exploitation in the ditch

The nonwoven made from recycled fibres was produced from the blend of natural and synthetic fibres. During six months of exploitation only the natural components of the nonwovens are biodegraded. The synthetic fibres forming the nonwoven are biologically resistant and keep their mechanical parameters (Figure 8). Consequently, only a slight reduction of the mechanical parameters of the nonwoven made from recycled fibres is observed.
